Manhole Inspection Summary

Manhole # S29SS1008MH

Insp Date: **10/7/08 12:20 PM**

Location Address: **4800 WILMSLOW RD**

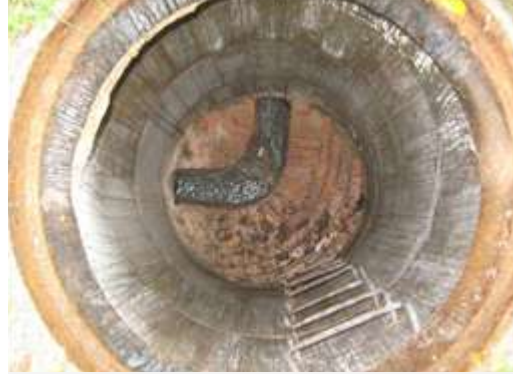
Top View

Corbel and Barrel infiltration. Bench and Channel debris.

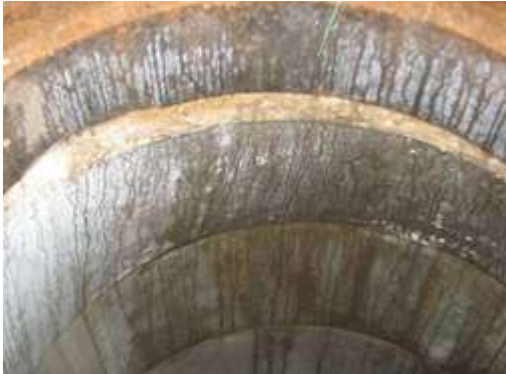
Defect

Frame offset. Corbel infiltration.

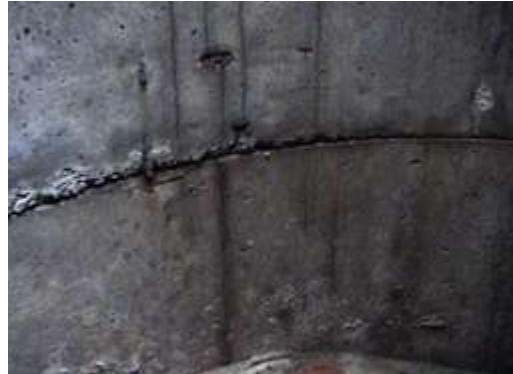
Defect

Barrel infiltration.

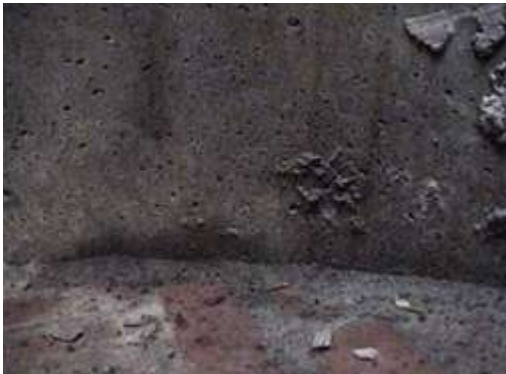
Defect

Barrel infiltration.

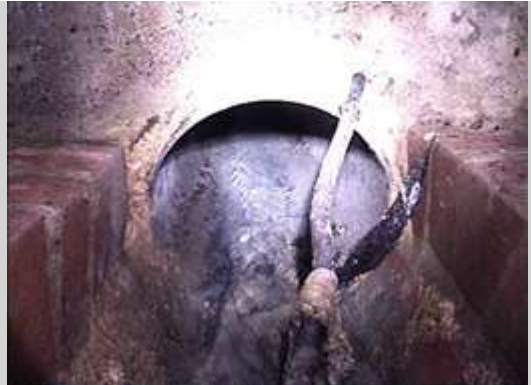
8 in. Circular Gravity Sewer Pipe Out @ 12 O'Clock

Pipe Material: **Clay** ☐ Pipe Lined

Invert Depth: **9.96** (ft.) Flow Characteristics: **Slow**

Infiltration: **None** Pipe Seal Cond: **Unknown**

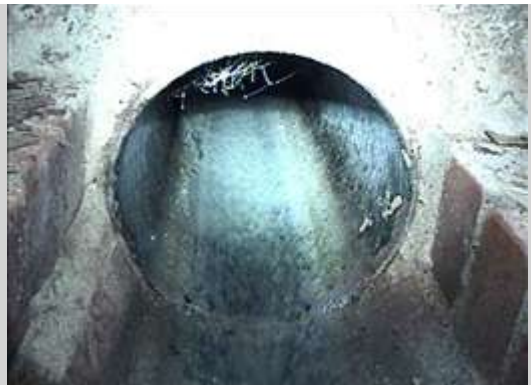
8 in. Circular Gravity Sewer Pipe In @ 9 O'Clock

Pipe Material: **Clay** ☐ Pipe Lined

Invert Depth: **9.60** (ft.) Flow Characteristics: **Slow**

Infiltration: **None** Pipe Seal Cond: **Unknown**
